EXHIBIT 107

IN THE UNITED STATES DISTRICT COURT FOR THE NORTHERN DISTRICT OF GEORGIA ATLANTA DIVISION

DECLARATION OF HARRI HURSTI

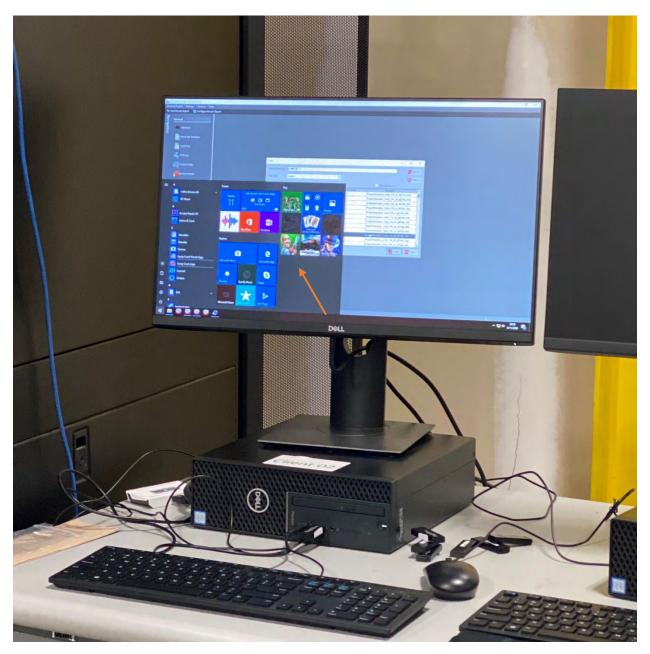
EXHIBIT C:

- 34. Since Georgia's Dominion system is new, it is a reasonable assumption that all machines in the Fulton County election network had the same version of Windows installed. However, not only the two computers displayed different entertainment software icons, but additionally one of the machines in Fulton's group of election servers had an icon of computer game called "Homescapes" which is made by Playrix Holding Ltd., founded by Dmitry and Igor Bukham in Vologda, Russia. Attached as Exhibit C is a true and correct copy of a photograph that I took of the Fulton voting system computer" Client 02". The icon for Homescapes is shown by the arrow on Exhibit C.

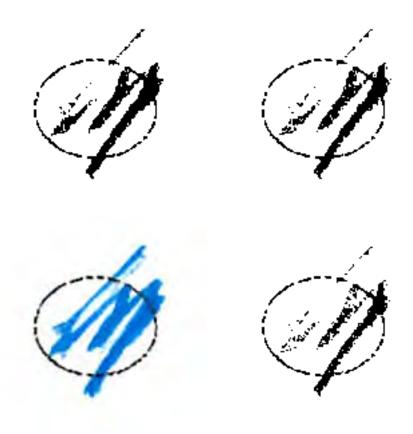
EXHIBIT H:

- 62. Dominion manual for ICC operations clearly show that the scanner settings are changed from neutral factory default settings. EXHIBIT H shows how these settings applied different ways alter how a blue marking is converted into Black-and-White only image.

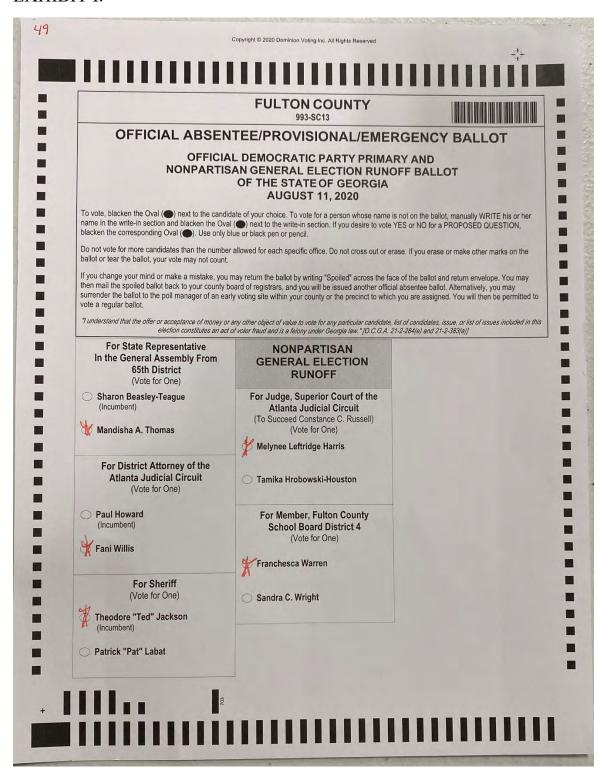
EXHIBIT I:

- 64. On the August 17th at Fulton County Election Preparation Center Professor Richard DeMillo and I participated in a scan test of August 11 test ballots using a Fulton County owned Dominion precinct scanner. Two different ballot styles were tested, one with 4 races and one with 5 races. Attached as Exhibits I and J show a sample ballots with test marks.
